CHUTE SECTION REPLACEMENTS

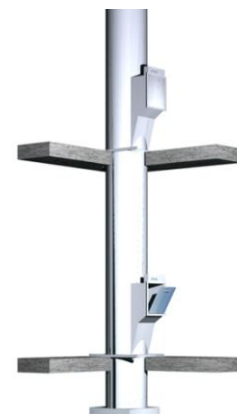
- Removal of broken chute liner
- Supply and installation of a NEW 2HR fire rated door
- Installation of NEW fire rated wall
- Painted and finished (As close as possible to previous wall/tiles)
